TARIMI MANSIONS PRESERVATION PROJECT:

DOCUMENTATION OF THE TARIMI MANSIONS 2004-05: HAMTUT AND AL-RIYAD

9 May 2005

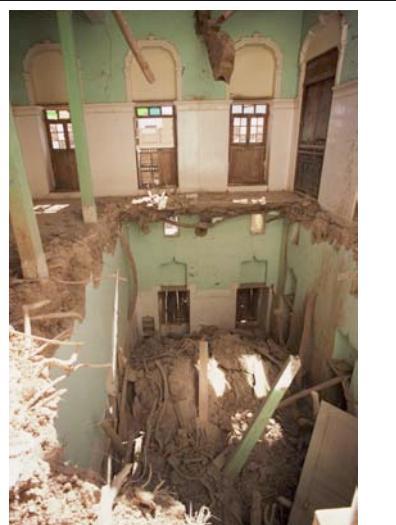
Al-Fijr, the mansion designed and originally owned by the architect Abu Bakr al-Kaf, suffered the collapse of the northwest section of the roof, which went down through three stories in October 2004 (Fig. 2). The collapse included a highly decorated room on the 2nd floor. In January 2004 with the execution of the updated feasibility study requested by UNESCO,³ the extensively termitedamaged beam on the 1st floor directly below this area was identified as requiring immediate emergency shoring. Unfortunately, funding was not secured in time to save the three-story area of collapse. The building still requires emergency stabilization and is a candidate for documentation and adaptive reuse. Muhammad Hasan al-Kaf is the caretaker of al-Fijr.

Fig. 2: An area of al-Fijr collapsed as a result of a termite-infested beam.

Immediate emergency repairs to the roofs of the Hamtut and al-Riyad are required if these two buildings are to be saved. In addition, funding for emergency stabilization of al-Fijr is being sought to prevent further collapse. For the upcoming season, al-Fijr is a priority for documentation. If the team is large enough, it is possible that we may tackle one of the other large mansions, probably Dar Mihdhar.

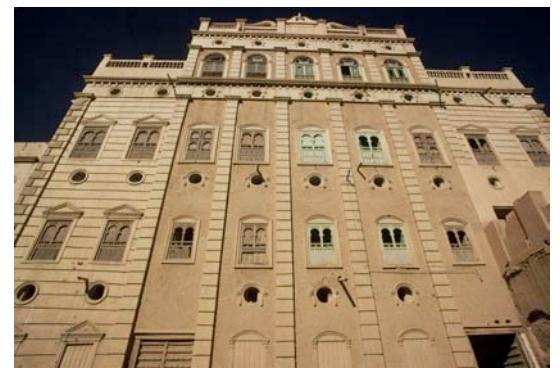
Muhammad bil Samayit is the family member responsible for Dar bin Sahil al-Kaf (Fig. 4). Although rented up until four years ago, this mansion is currently abandoned and in fair condition. We were told that the family moved to Saudi Arabia in 1967 at the time of South Yemen's independence from the British. Dar bin Sahil was then expropriated by the Marxist government in the early 1970s. The southeast wing has partially collapsed and roofs and terraces range from good to poor condition (Fig. 5). The mansion is quite large and has some interesting Art Deco details (Fig. 6), including decorative carved plaster window inserts (Fig. 7). Dar bin Sahil requires some emergency work to roofs and terraces to stabilize it and is a candidate for documentation and adaptive reuse. Both Al-Haywar and Dar bin Sahil may have been designed by Abu Bakr al-Kaf, as they are stylistically similar to other buildings known to be his work.

Fig. 4: Dar bin Sahil is an impressive abandoned mansion in fair condition.

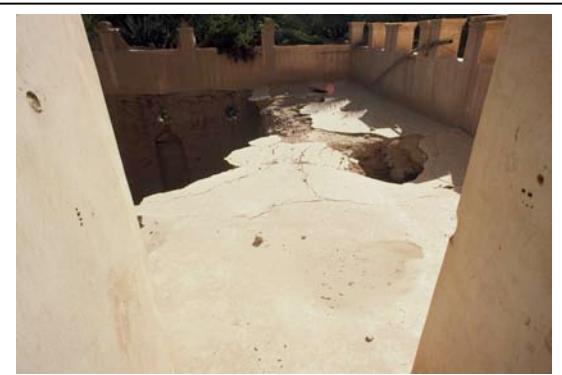
Fig. 5: Some of Dar bin Sahil's terraces are in extremely poor condition.

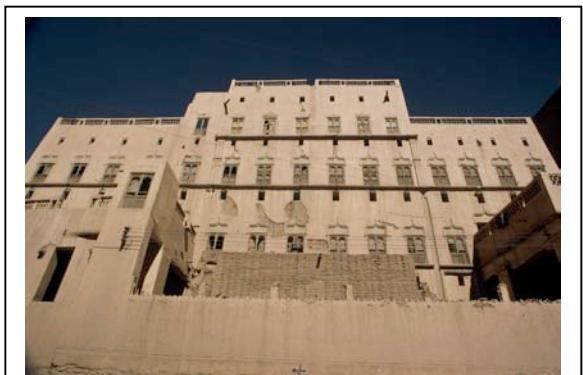
Rahman al-Kaf, grandfather of 'Umar, thus making it a very significant structure. 'Umar's father, Sheikh and his brother Abdallah, were both born in this mansion. It is probable that Sheikh's children were born in this house as well, including 'Umar. The building, also known as Dar Sahil, is in fair-to-poor condition and presently abandoned. The southeast area of the building has collapsed through three stories (Fig. 9). The interior exhibits unusual early decorations not seen before in other mansions (Fig. 10). This house was the first to be electrified in Tarim. The remains of the generator room are still present across the street. Hussain's father, 'Umar al-Mihdhar, was also the first person to bring a radio into the Valley. Dar Mihdhar requires emergency stabilization and is a candidate for documentation and adaptive reuse.

Fig. 8: Dar Mihdhar is another significant abandoned mansion in fair-to-poor condition.

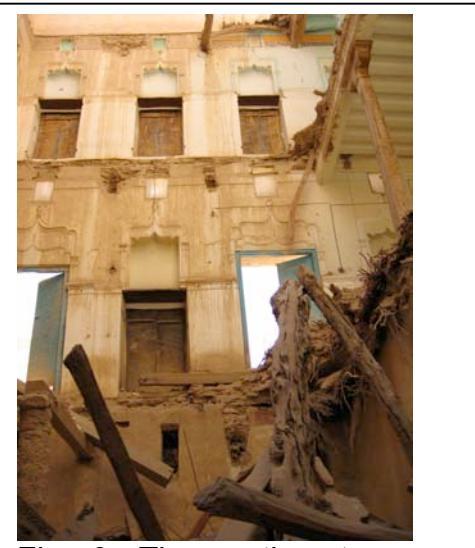
Fig. 9: The northeast area of Dar Mihdhar has collapsed.

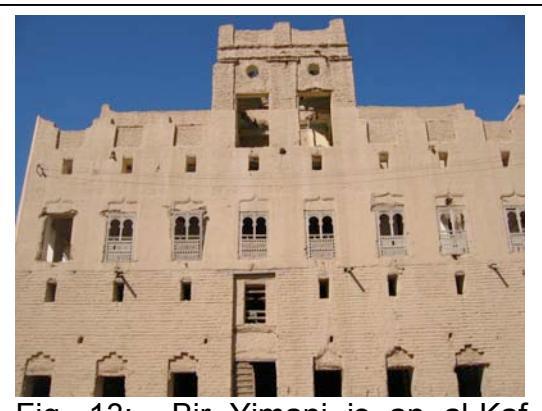
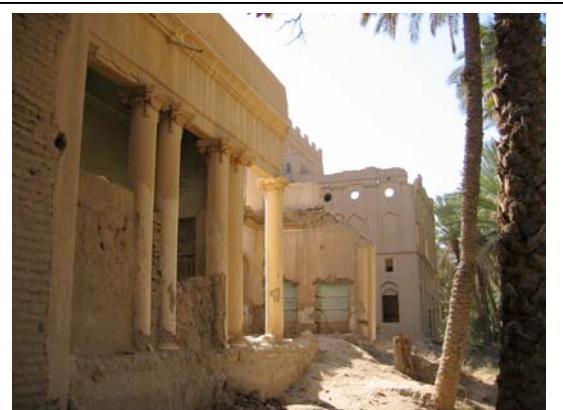
Bir Yimani was revisited. This structure is located in the palm groves on the outskirts of Tarim and was used by the al-Kafs as a guest house for visiting British officials and others. It was identified as beyond repair in the original feasibility study performed in November of 2000.⁴ It continues to deteriorate (Figs. 13 and 14).

Fig. 13: Bir Yimani is an al-Kaf mansion located int eh palm groves on the outskirts of Tarim. The 2000 feasibility study assessed it as beyond repair.

Fig. 14: Bir Yimani has highly articulated decorative details.

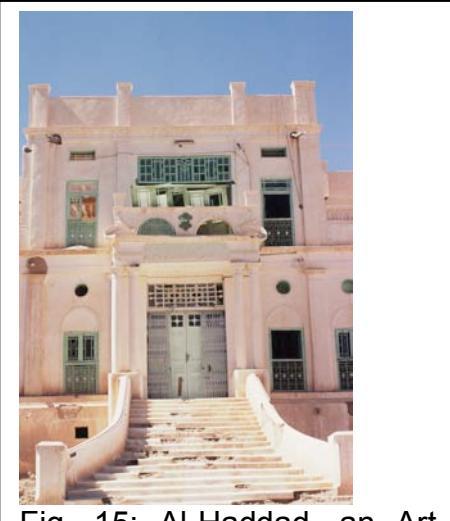
Al-Haddad, an Art Deco mansion designed by Abu Bakr al-Kaf and located in the Aydid district, was also reviewed. This building is in relatively good condition. Unfortunately, a change from last year is that the balcony doors at the upper floor have fallen down (Fig. 15). With minor investment, a carpenter could reinstall the doors.

Fig. 15: Al-Haddad, an Art Deco mansion, has suffered the collapse of it balcony doors.

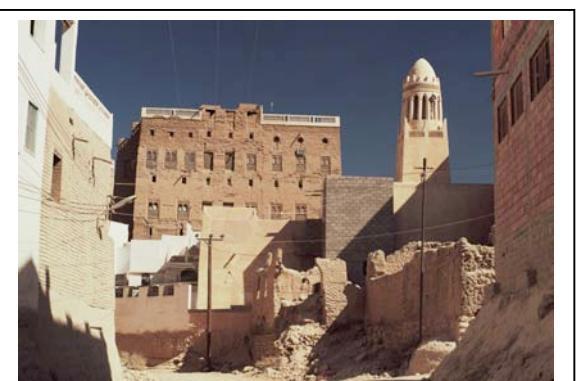
Fig. 16: The area around the Sarjis Mosque is part of the historic core of Tarim, but is in fair-to-poor condition.

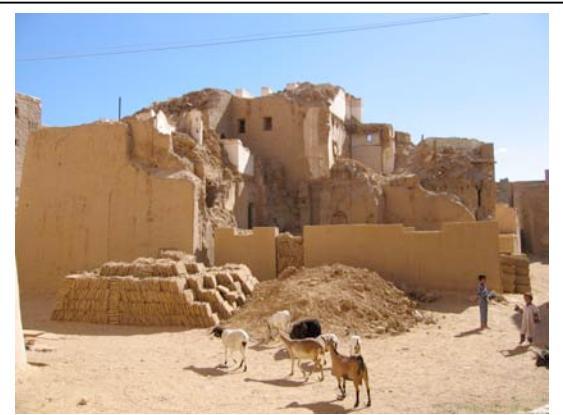
Fig. 17: In the historic core of Tarim, near al-Ranad palace, there are many abandoned and collapsing traditional buildings.

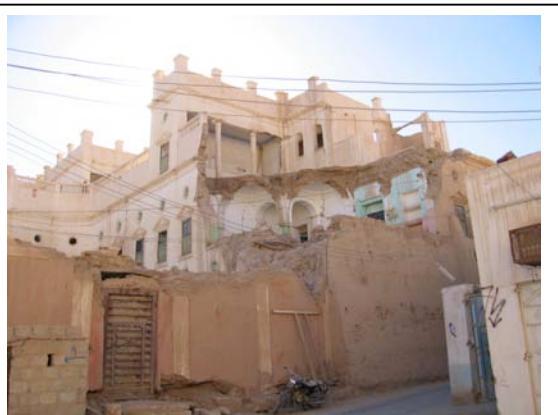
The zone between the al-Mihdhar Mosque and Qasr al-Ranad is also of particular interest. Although no other significant villas are located in this area, this neighborhood is the traditional heart of historic Tarim. The building stock in this neighborhood was in similar condition to the previously stated area, although there are substantially more abandoned buildings falling into a ruinous state (Fig. 17). Al-Ranad, the Kathiri sultans' palace, was recorded this year by a team from the General Organization for the Preservation of Historic Cities of Yemen (GOPHCY). Currently reused as the police station, it too has suffered collapse of a northeast section of the building (Fig. 18). There is also substantial new construction on the main square itself facing Qasr al-Ranad.

Fig. 18: A portion of the northeast wing of al-Ranad palace has collapsed.

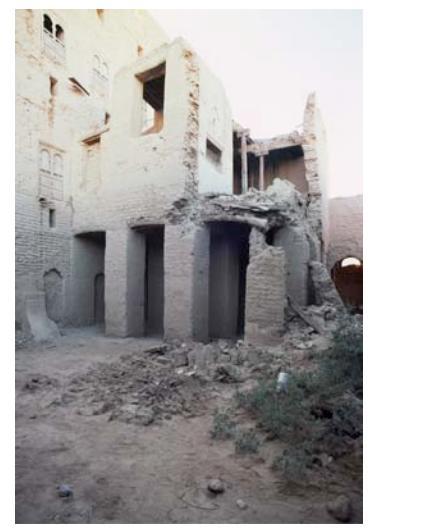
A central courtyard is ringed by stairwells to the east and west, and corridors to the south and north. On the ground floor level, the courtyard served as the original kitchen surrounded by storerooms. To the north, a kitchen addition to the 1st floor suffered partial collapse in 2002 (Fig. 29). In this area, a larger courtyard is framed by the massive piers, which support the kitchen wing, and secondary rooms in poor condition along the north and east courtyard walls. The piers are severely undermined (Fig. 30) and the remainder of the kitchen wing threatens to pull down part of the north elevation of the original building with it.

Fig. 29: The northwest kitchen wing of the Hamtut collapsed in 2003.

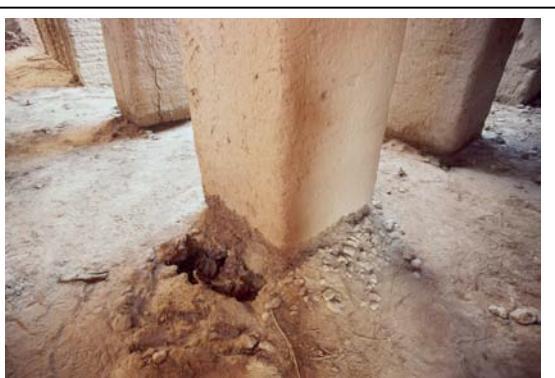
Fig. 30: The massive piers supporting the Hamtut's northwest kitchen wing are severely undermined, risking further collapse.

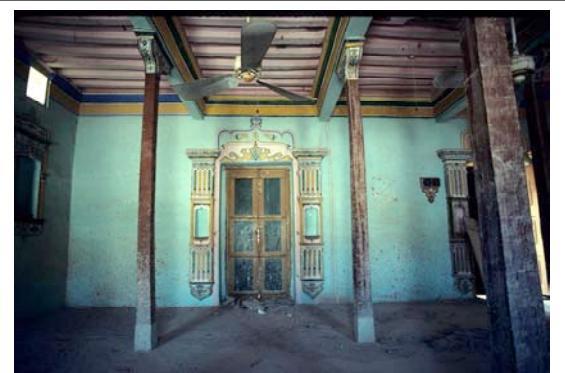
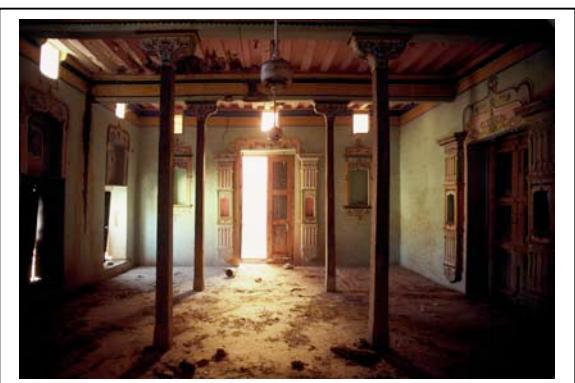
The 2nd floor of the Hamtut exhibits greater deterioration because of the precarious condition of the roofs. Comparison of photographs taken in November 2000 of a highly decorated 2nd floor room in the Hamtut are also proof that extensive damage has occurred in the intervening years (Figs. 31 and 32). A bid for emergency stabilization from Ba Mumin came in at \$52,000 with an escalation factor of 15% if the contract is not executed for a year.

Fig. 31: A 2nd floor room in Hamtut photographed in 2000.

Fig. 32: The same room as documented in December 2004. The roof over this room is now in precarious condition with several gaping holes.

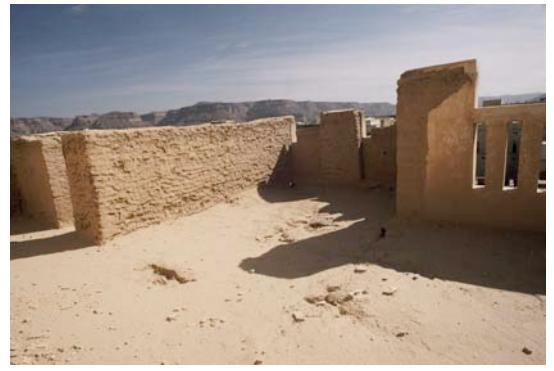
Fig. 35: The roofs of al-Riyad are in dangerous condition as exhibited by these sink holes.

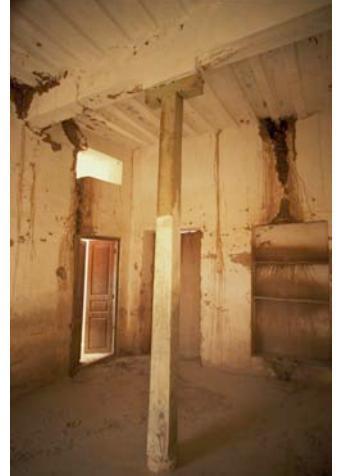
The main entrance to the mansion is located in the southwest corner. Side-toside stairwells lead to the two sides of the house. A central lightwell divides the north and south portions of this three-story structure. Rooms display restrained Art Deco decoration (Fig. 34) very similar to that of Dar al-Salam mansion. All of the roofs are in deplorable condition with sink holes (Fig. 35). A 1st floor room in the northwest corner of al-Riyad is on the verge of collapse with its stone columns sinking into the floor. Other rooms are in precarious condition as a result of leaks through the roofs (Fig. 36).

Fig. 36: The interiors of al-Riyad exhibit extensive damage as a result of leaking roofs.
